# **Earthquake of 30 September 2009, Mw7.6, Padang, Sumatra, Indonesia**

## **A Preliminary Reconnaissance Report**

By: Dr Mehdi ZARE, Dr Ebrahim Haghshenas and Dr Afshin Kalantari,  
International Institute of Earthquake Engineering and Seismology (IIEES)  
Tehran, IRAN

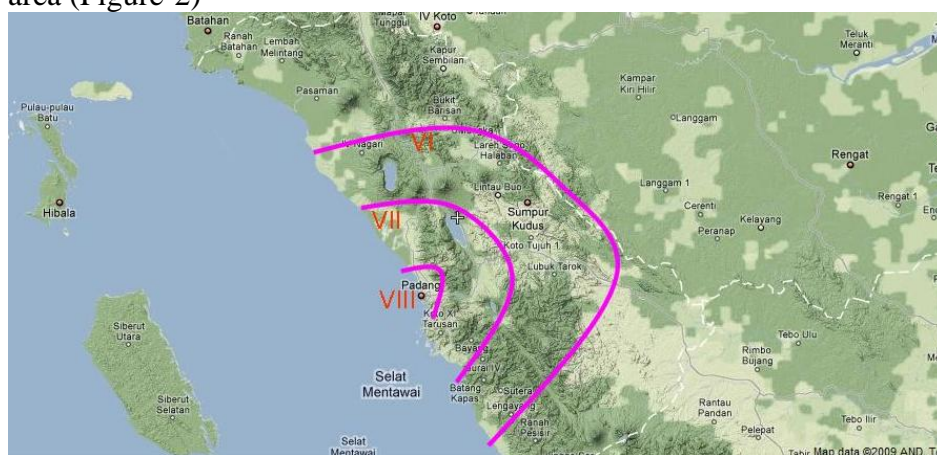
Padang earthquake which occurred on 30 September 2009, has produced the maximum acceleration of earthquake waves at Padang region between 200 gals in Padang and 120 gal in Padang Panjang. The maximum intensity is estimated to be occurred in Padang, to be VIII in EMS98 macroseismic scale, due to greater damages to engineered structures and a possible site effect. The maximum intensity was estimated to be VII in Padang Pariaman, VI in Bukit Tinggi and Tandikat landslide area (Figure-2)

Figure-2: Macroseismic Intensity assessment for the prone area of the Padang earthquake of 20 September 2009.

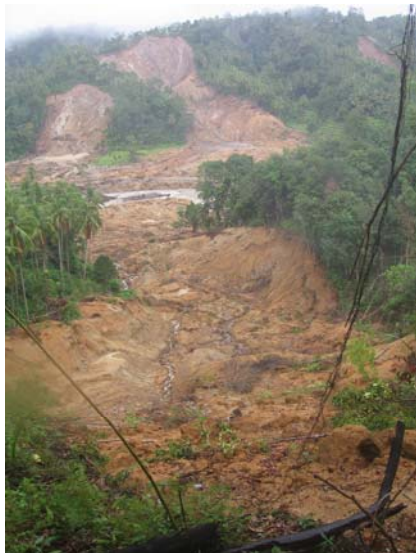
ReliefWeb reported that over 1000 landslides were triggered by this earthquake. Based on the reports 400-600 death of the total of more than 1200 death caused by earthquake were killed by landslides. 3 villages were completely demolished by landslide and many others were damaged (Figure-3). Many roads were damaged or blocked by landslides and result in difficulties in rescue efforts.

The most destructive landslides happened during this earthquake are concentrated in the Tandikat regency. A cluster of villages including Pulu Koto (or Pulu Air), Cumunak, Lubuk Laweh and Timor Koto, were totally demolished or severely damaged in this area.

Figure-3 : Two giant landslides happened on Tandikat regency along the Lembah Tiga valley. Upper part of the photo: Cumanak landslide wiped and buried the village of Cumanak and killed near 200-300 peoples gathered for a wedding ceremony. Lower part of the photo: a landslide adjacent to the Lubuk Laweh landslide cut a road.
