## SOME LESSONS FROM THE SARPOL-E ZAHAB EARTHQUAKE OF NOVEMBER 2017

**Keywords:** Sarpol-e Zahab earthquake, Site effects, Earthquake damage, Seismic response

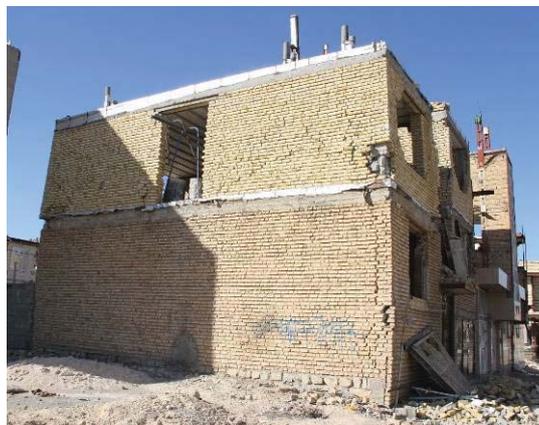
1. Inefficiency of the current levels of confinement in masonry buildings specified in Standard 2800 and version 2 of the Discussion 8 of the National Building Code to provide adequate seismic resistance for masonry buildings taller than one storey (see Figure 1).

Figure 1. Inadequacy of the code provisions for confined masonry.

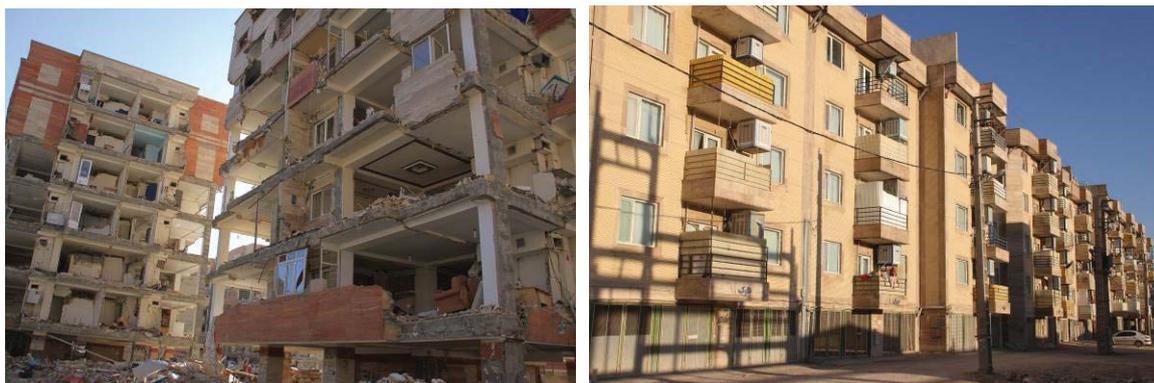
2. The severe damage to some code-designed framed buildings was unexpected. The damage to framed buildings were evidently a function of the type of soil the buildings were built upon. In Sarpol-e Zahab, the seven-storey RC framed buildings of the Maskan Mehr complex situated on the alluvial soft soil near the river were severely damaged and

some collapsed. The very high intensity of shaking in this location during the earthquake was evident, not only from the level of structural damage, but also from the major damage to the non-structural elements such as infills. On the other hand, almost similar height buildings of another Maskan Mehr complex in Sarpol-e Zahab, which were located on a foothill and almost the same distance from the epicentre compared to the RC buildings of the other complex, were not damaged at all. In fact, as it can be seen in Figure 2, even all the free-standing thin masonry walls situated at the roof level survived the earthquake, which indicates no or very little dynamic magnification occurring at the latter site. It can be noted that, two sets of buildings, which according to 2800 Standard have almost identical natural periods of vibration and being effectively the same distance away from the epicentre, behave completely different during the earthquake shaking. The difference in response is evidently due to the type of soil they were located on. In the proposed paper, an attempt is made to correlate the response factor (B) of the Standard 2800 for these two sets of buildings, with their actual seismic performance.

Figure 2. Site effects on two similar building complexes in Sarpol-e Zahab.
