LESSONS FROM NOVEMBER 2017, M7.3 EZGELEH EARTHQUAKE

Keywords: Construction deficiencies, Design deficiencies, Ezgeleh earthquake, Crisis management

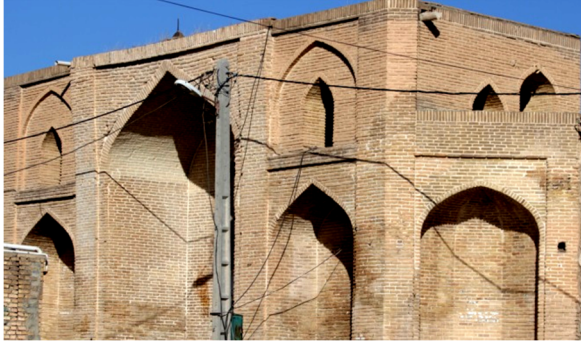
Most of masonry buildings were unreinforced, with no lateral force resisting systems. Although some old arch brick ones survived the earthquake (Figure 1), many of the walls and roofs collapsed during the not long lasting quake shocks (Figure 2).

Figure 1. Survived old building with arch bricks.

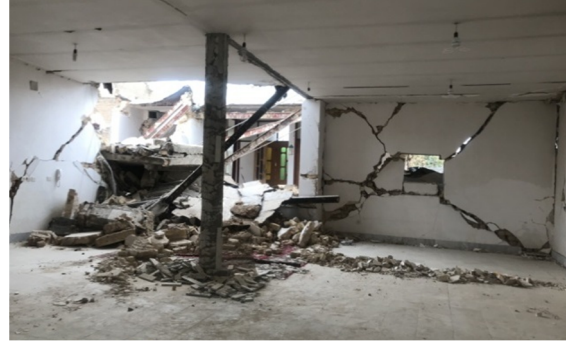
Figure 2. Damaged walls and roofs.

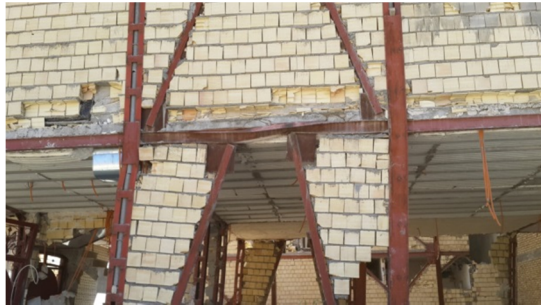
Local and international design codes should be regarded in engineering calculations. In many cases, neither structural nor non-structural members were properly designed in accordance with design guidelines. For instance, incorrect chevron beam design, insufficient development length of reinforcements, and insufficient out-of-plane lateral support of infills were noticeable in structural systems (Figure 3).

Figure 3. Structural failures due to design errors: (a) Chevron beam failure; (b) Rebar debonding in concrete; courtesy of Milad Shamsodin.
