POST-EARTHQUAKE RECONNAISSANCE OF SARPOL-E ZAHAB CONCRETE BUILDINGS AFTER 6.4 MAGNITUDE AFTERSHOCK

Keywords: Sarpol-E Zahab earthquake, Ductile behavior, Damaged structure, Infill panel

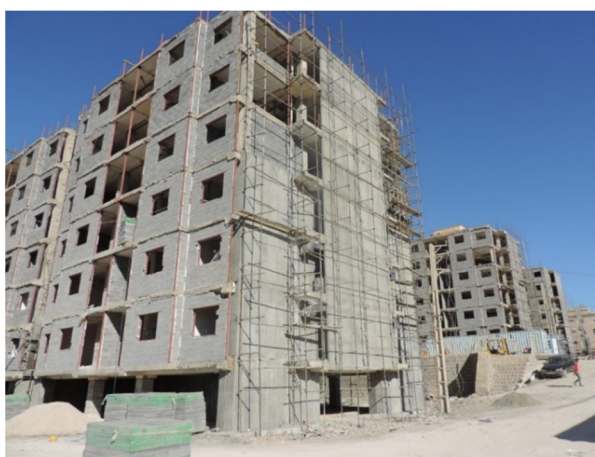
Figure 1. concrete structure having a shear wall in one direction and a moment resisting frame in another.

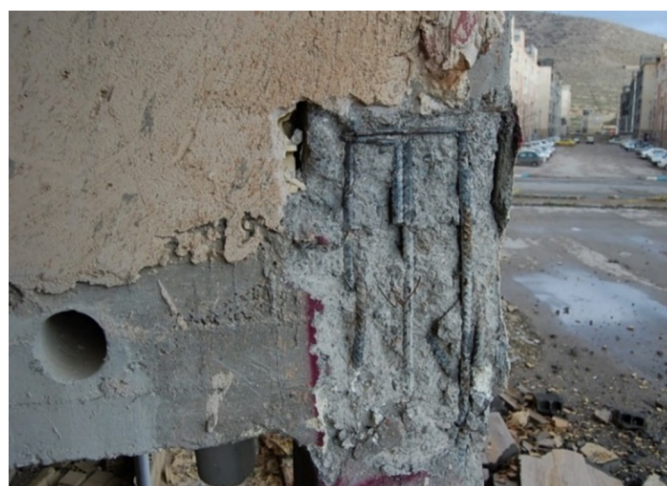
Ductility of the concrete elements depends highly on reinforcement detailing. Our observations show that insufficient bending details in stirrups, inadequate overlap length for longitudinal bars and deficient curing of the concrete are the main reasons of damages in such buildings.

Figure 2. Lack of sufficient stirrups in columns.

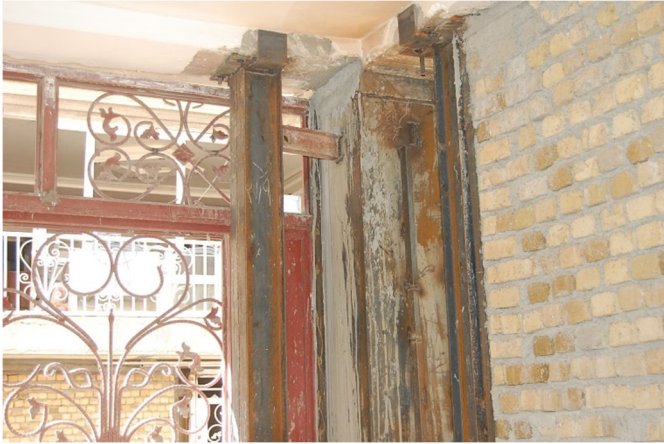
Figure 3. columns strengthening by steel Jacketing.

Most regular repairing methods are as: columns strengthening by steel/concrete jacketing (Figure 3) or FRP, addition of shear walls or strengthening the existing ones (Figure 4) and foundation rehabilitation. Despite the criteria to design the columns stronger than beams, no plastic hinge was observed in beams and all of them were occurred in columns. This may be due to having a thick concrete floor connected to the beams, resisting against moment and protect them for

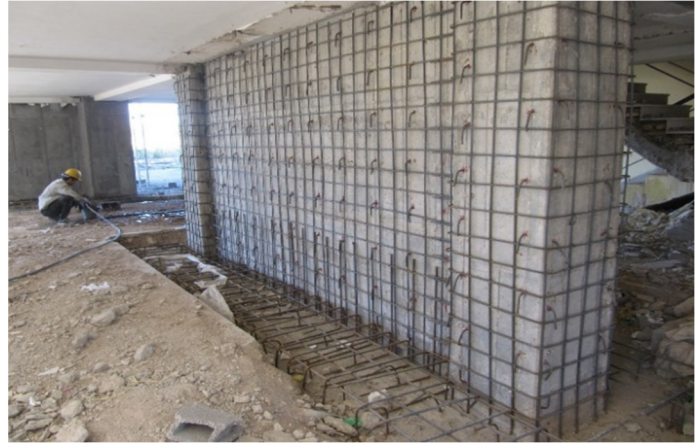
Figure 4. Meshing on the shear wall.

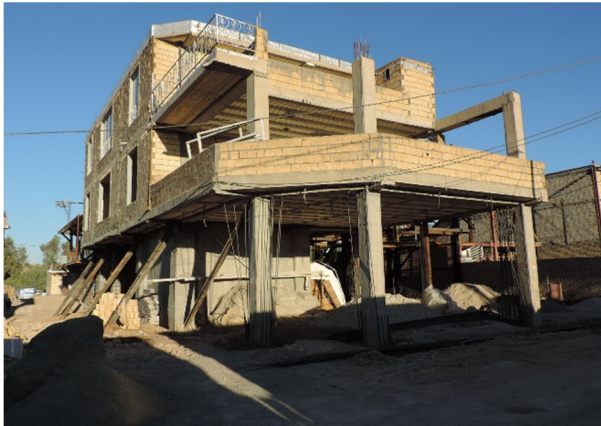
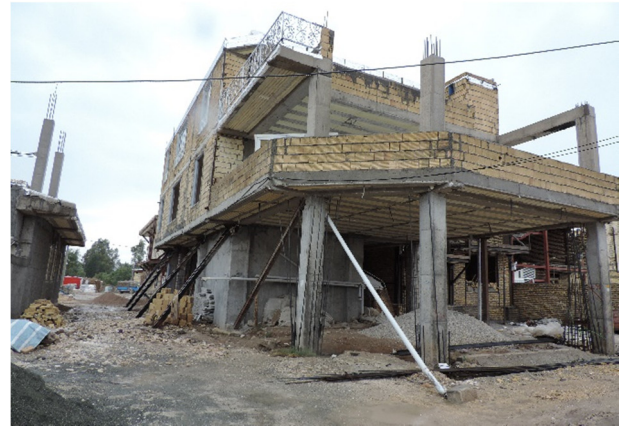
Efficiency of the repairing methods are naturally tested in 6.4 magnitude aftershock occurred on 25 November 2018, which are reported in this paper. Figure 4 shows a repaired three-story concrete building, before and after the aftershock.

(a) Before the aftershock

(b) After the aftershock

Figure 5. A repaired three-story concrete building.
