THE PERFORMANCE OF URM WALLS DURING THE 2017 SARPOL-E ZAHAB EARTHQUAKE IN IRAN

Keywords: URM buildings, Masonry walls, Damages, Sarpol-e Zahab Earthquake

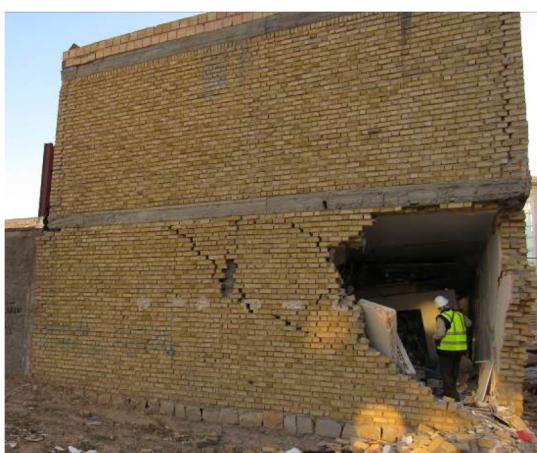
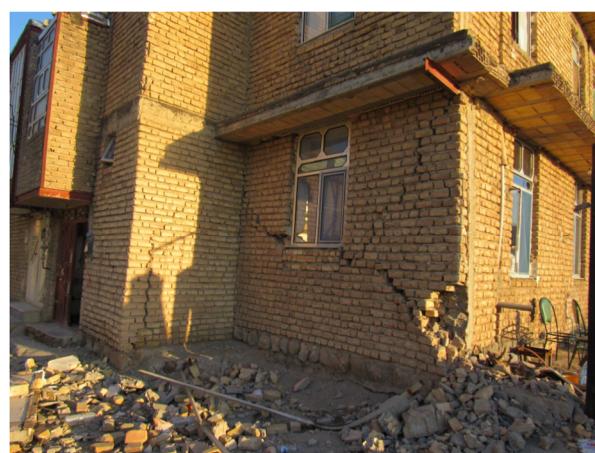
Figure 1. Observed damages in URM walls in Sarpol-e Zahab earthquake.

According to the significant number of the URM buildings (traditional and confined) in Iran and importance of the behavior of URM walls, in this article, different types of damages in load bearing and non-structural masonry walls in URM buildings observed after 2017 Sarpol-e Zahab Earthquake have been reported, see Figure 1. Different types of in-plane mode of failure, out-of-plane cracking and combined in-plane and out-of-plane failure were observed in URM shear walls.
