EXPERIMENTAL INVESTIGATION OF BRICK MASONRY ARCHES' (VAULT AND RIB COVER) BEHAVIOR UNREINFORCED AND REINFORCED BY C-FRP UNDER VERTICAL AND HORIZONTAL LOAD SIMULTANEOUSLY

Keywords: Horizontal and vertical loading, Crack, C-FRP, Vault and spring

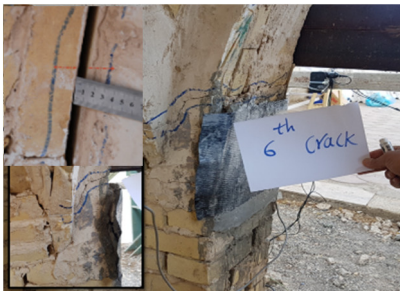
Figure 3. Separating Mortar and fiber reinforcement from bricks in the reinforced structure.

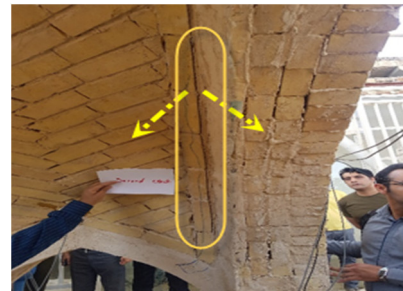
Figure 4. Opening between the vault and the rib cover in the unreinforced structure.
