A PROPOSAL FOR PLASTIC HINGES MODIFICATION FACTORS FOR DAMAGED STEEL MOMENT FRAME

The main assumption of this paper relies on the principle that an exhaustive list of possible damage states that a special steel moment frame may be experience after the main shock.

This paper presents a methodology and results of an analytical approach for evaluating the effect of initial damage in special steel moment frame component on beam and column moment-rotation plastic hinges depending on damage state. These expressions can be used to assess the performance loss of a building that has been damaged by a sequence of seismic events characterized by a principal earthquake with medium-to-high intensity, followed by aftershocks with comparable intensity. For this purpose, the analytical based procedure has been proposed for modifying the steel beam and column moment- rotation plastic hinges that have entered the plastic range in several damage states. The Finite element analysis employing 3D shell elements is implemented to model a W-section steel beam and a box column element. Firstly, various damage states as a function of element's drift level induce these sections subjected to cyclic loading

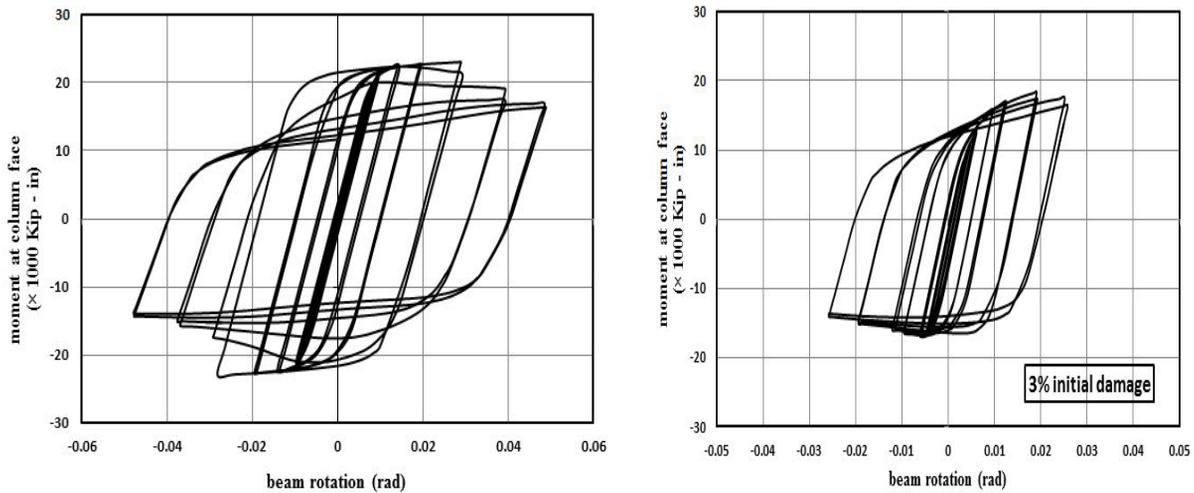
Figure 1. The damaged beam hysteresis curve with and without initial damage

The moment-rotations of the W-section beam without initial damage and 3% initial damage are illustrated in Figure 1. The moment-rotation of damaged beam element for 3% initial damage state exhibits unsymmetrical behavior on the first

and the third quadrant of hysteresis curve.

Consequently, it was anticipated that the energy dissipation of damaged beam behavior has been decreased with increasing the initial damage. These variations in seismic behaviors of damaged elements were faced engineers with some problems. It is ambiguous that the designed structures with current designing codes can be stable under mainshock-aftershock sequence or not.
