MAJOR HISTORICAL EARTHQUAKES IN ROMANIA AND CONTEMPORARY SEISMIC RISK MANAGEMENT ACTIVITIES

Keywords: Risk Management, Seismic Losses, Building Typology

ABSTRACT

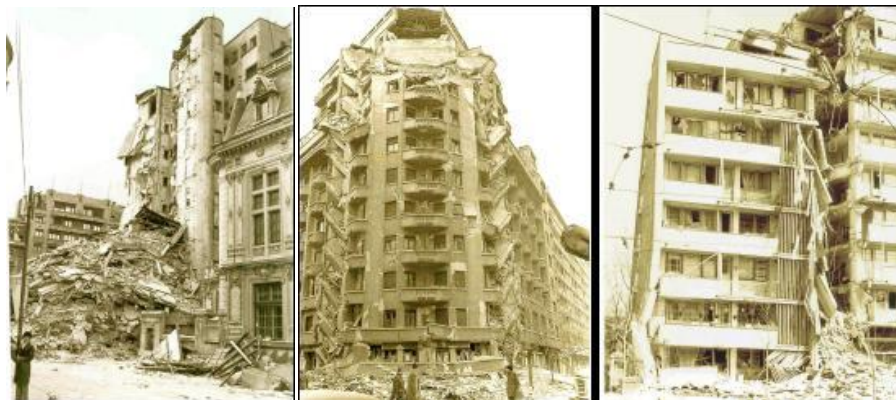
Figure 4. Total and partial collapse of the Bucharest RC tall buildings in 1977 earthquake

In Table 1 are presented the most notable buildings collapsed by the 1977 earthquake. The lack of structure horizontal-regularity, lack of mass vertical-symmetry, accumulated damage during the 1940 earthquake, low strength concrete (mean of compressive strength less than 200 daN/cm²), soft ground floor due to commercial use of the floor (no infilled masonry walls) and dynamic characteristics clearly explain the collapse of buildings in the centre of Bucharest.

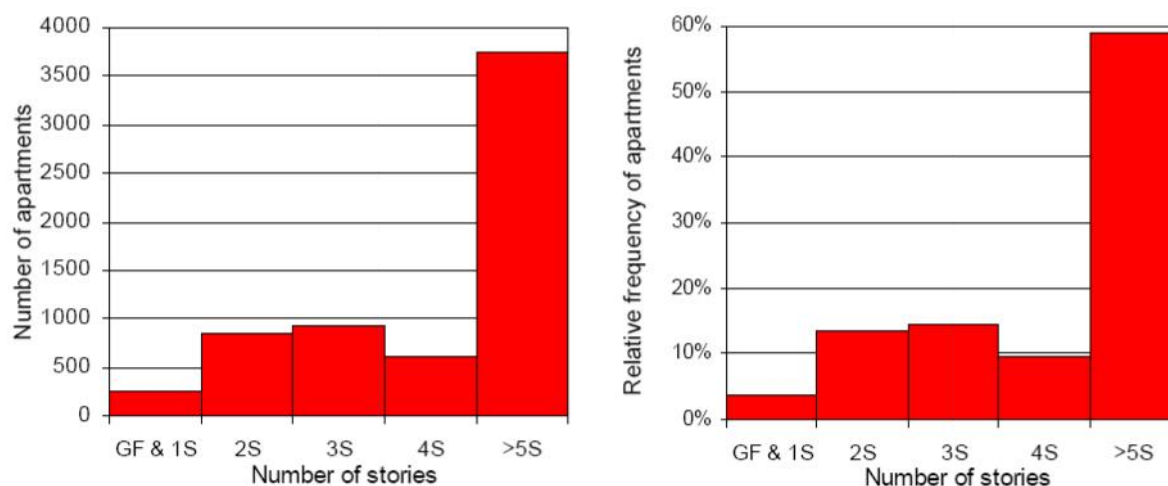
Figure 6. Housing units distribution for seismic risk class 1 buildings in Bucharest

In Figure 6 is presented the distribution of seismic risk class 1 buildings housing units by the height of the building. One can notice that about 60% of the housing units are situated in buildings with more than 5 storeys.
