POST-EARTHQUAKE RECONNAISSANCE OF SARPOL-E ZAHAB STEEL BUILDINGS AFTER 6.4 MAGNITUDE AFTERSHOCK

Keywords: Sarpol-e Zahab earthquake, Ductile behavior, Damaged structure, Infill panel

Results of a post-earthquake reconnaissance on steel buildings of Sarpol-e Zahab are presented in this paper. Common damages and defects on such buildings after the main shock as well as the most important repairing methods are reported.

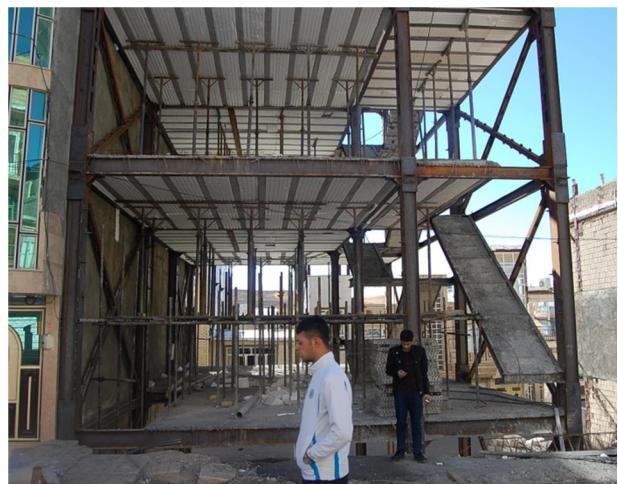
Figure 1. A steel structure with moment resisting frame in one direction and braced system in another.

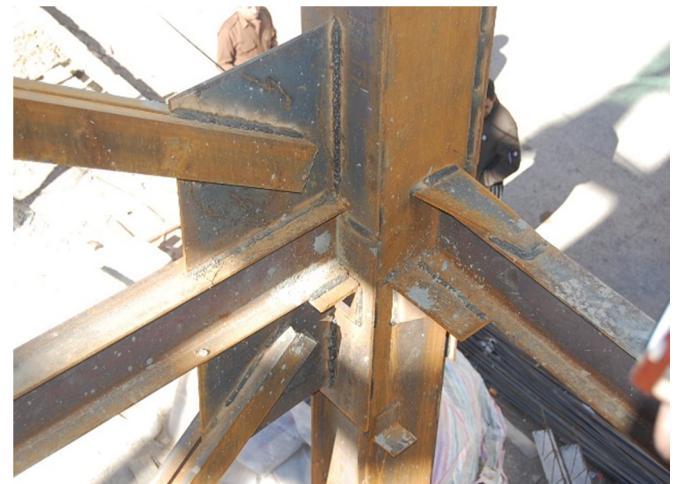
Stability of moment resisting frames depends mostly on the quality of their connection welding; they must be normally sufficient to transfer full capacity of the beam to the column. Despite, this issue was not given sufficient attention in some buildings.

Figure 2. The connection plate dimensions and the welding length are insufficient.

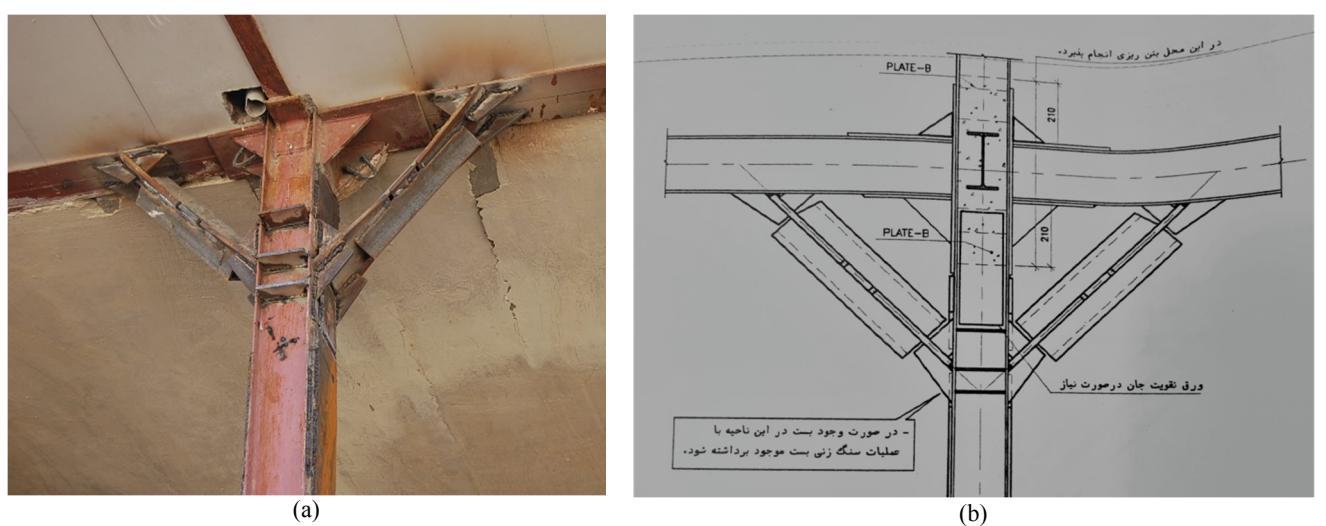
Figure 3. An example of repairing a connection (executed and in drawings).

In general, steel structures are repaired by column strengthening, foundation rehabilitation, adding bracings (regular bracings or BRB) and strengthening the connections, shown in Figure 3. The column is strengthened by adding a series of longitudinal steel plates or horizontal clamps (for battened columns) or by adding new columns close to the damaged columns.

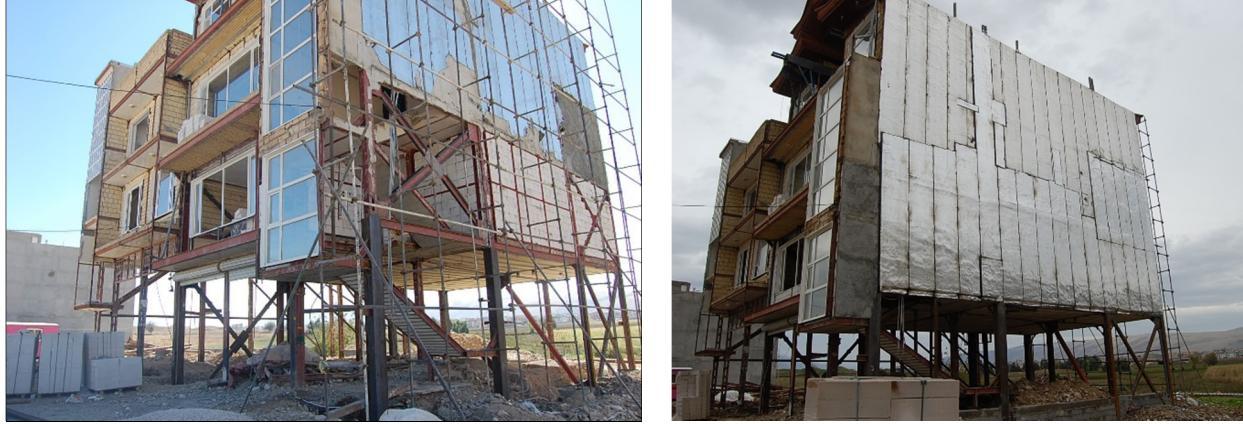
Efficiency of these repairing methods are naturally tested in 25 November 2018 6.4 magnitude aftershock, which are reported in this paper. Figure 4 shows a repaired four-story steel building, before and after the aftershock.

(a) Before the aftershock (b) After the aftershock *Figure 4. shows a repaired four-story steel building.*
