## COMPARATIVE EXPERIMENTAL STUDY ON SEISMIC RETROFIT OF EXISTING GAS RISERS

**Keywords:** Gas riser, Seismic performance, Experimental Evaluation, Retrofit design

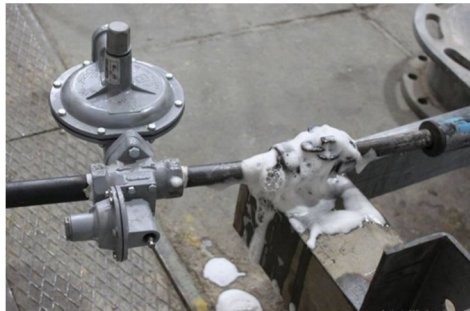
Figure 1. Failure process of the riser under lateral displacement.

As shown in Figure 1, the failure of the riser starts from the connection of the mitter stop valve to the upper pipe where the polymer insulating unit exists. The failure starts with gas leakage from the insulation and ends to the total insulation unit breakout. Figures 2 and 3 show the verification tests of some alternatives discussed in the paper.

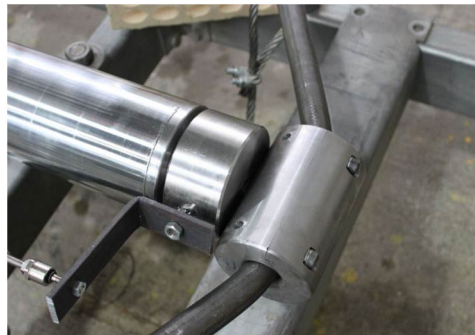
Figure 2. Sample test performed by steel clamp.

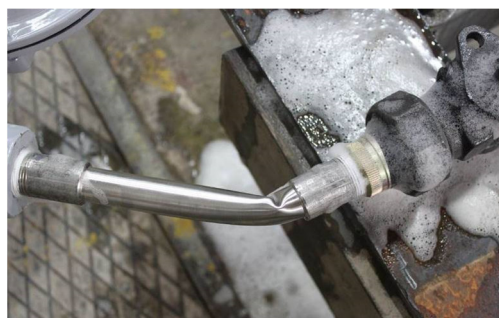
Figure 3. Results of the test for retrofit alternative by using flexible pipe between the stop valve and the regulator.
