THE EFFECT OF AFTERSHOCKS ON STRUCTURAL LIFETIME

Keywords: Structural Lifetime, Time-dependent fragility curve, Aftershocks, IDA, Performance

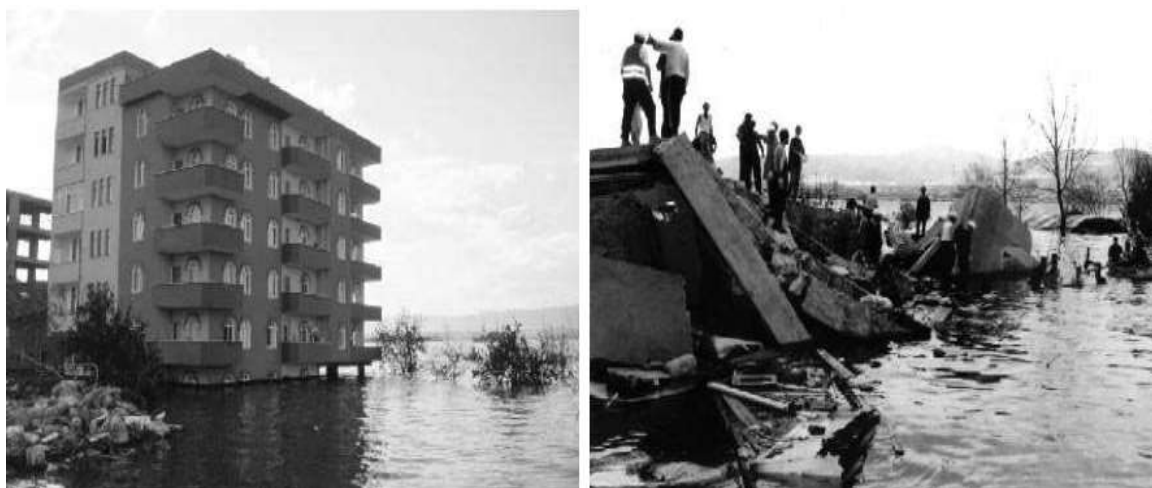
Figure 1. Collapse of a building caused by aftershock in turkey 1999 (Yeo & Cornell, 2005).

Structures are generally under the risk of earthquake events, especially in regions with high seismicity. However, rather than occur individually, the seismic events tend to happen in sequence of the mainshock and the multiple aftershocks, which would cause additional damage to the damaged buildings in post-mainshock environment and increase the probability of collapse (Figure 1).
